# THE STONES OF TIAHUANACO

A STUDY OF ARCHITECTURE  
AND CONSTRUCTION

JEAN-PIERRE PROTZEN  
AND STELLA NAIR

MONOGRAPH 75

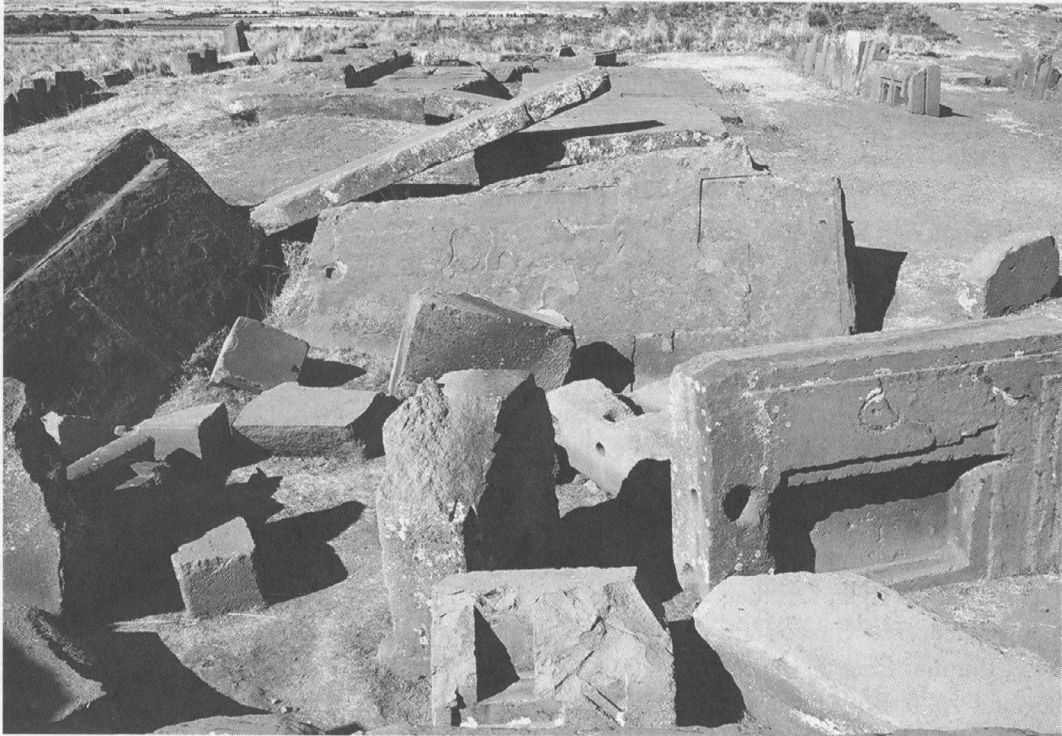
**Figure I.5.** Jumble of building stones at Pumapunku.

The archaeological site has suffered unspeakable damage ever since the arrival of the Spanish (Figure I.5). Not only did they mine the ruins to construct the colonial town and church of Tiahuanaco, but carted away building stones to as far away as La Paz, approximately 70 km from Tiahuanaco (Castro y del Castillo 1906:2 II).<sup>2</sup> Further havoc was brought about by colonial era treasure hunters who believed that major caches of gold and precious stones were waiting to be carted away. One such treasure hunt left a big and deep gash on Akapana, one of Tiahuanaco’s major platform mounds, destroying whatever architecture crowned the mound. Worse than the Spanish colonialists were the railroad barons of the early 1900s. The railroad line connecting the capital city of La Paz to the port of Guaqui on the shores of Lake Titicaca was run precisely through the archaeological site of Tiahuanaco. In the process uncountable building blocks, statues, and stelae were blown up with dynamite to provide ballast for the tracks (Baptista 1975:41). To add insult to injury, the inhabitants of the modern town of Tiahuanaco dismantled and destroyed nearly everything Georges Courty uncovered within days, even hours, of his excavations in 1903–1904 (Posnansky 1945:Vol. 2, 106). The depredation did not end there, but continued for many years and culminated in the probably well-intentioned, but ill-conceived and uninformed, reconstruction of the Kalasasaya, a large, enclosed platform structure (Figure I.6).

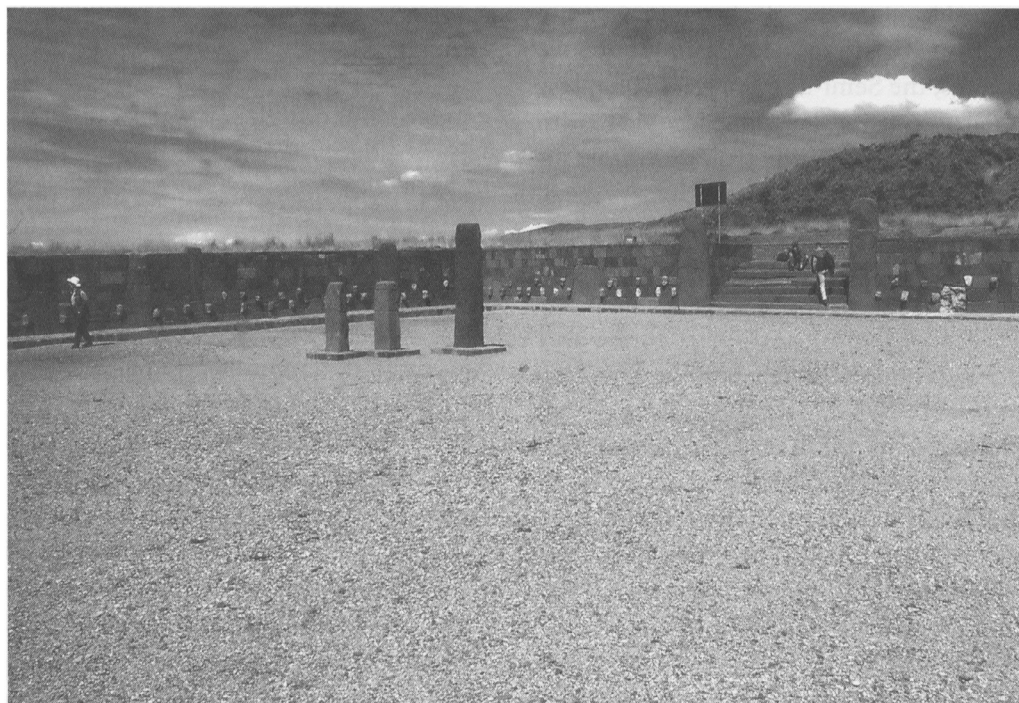
Figure 2.2. Walls of the Semi-Subterranean Temple with uprights and tenon heads.

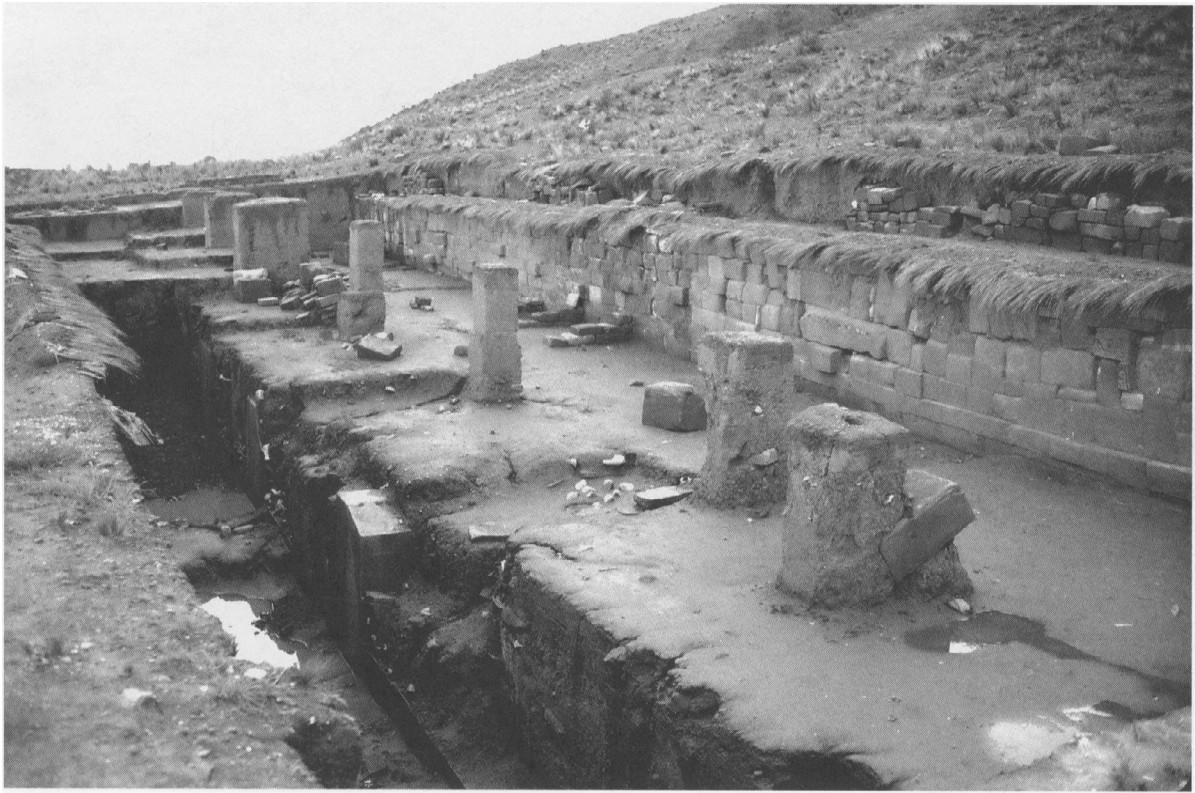
**Figure 2.15.** Basewall and second wall of Akapana's south side.

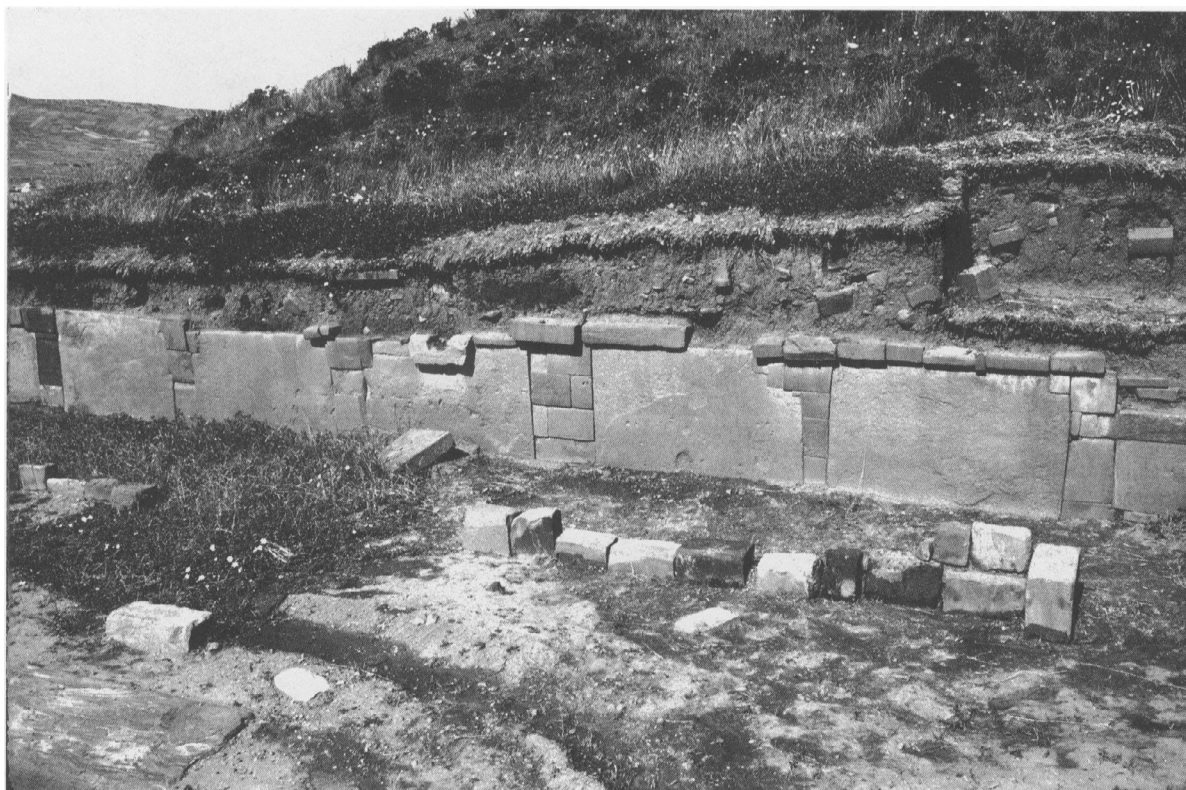
**Figure 2.22.** Second wall with spout (Type “d”) Akapana’s west side.

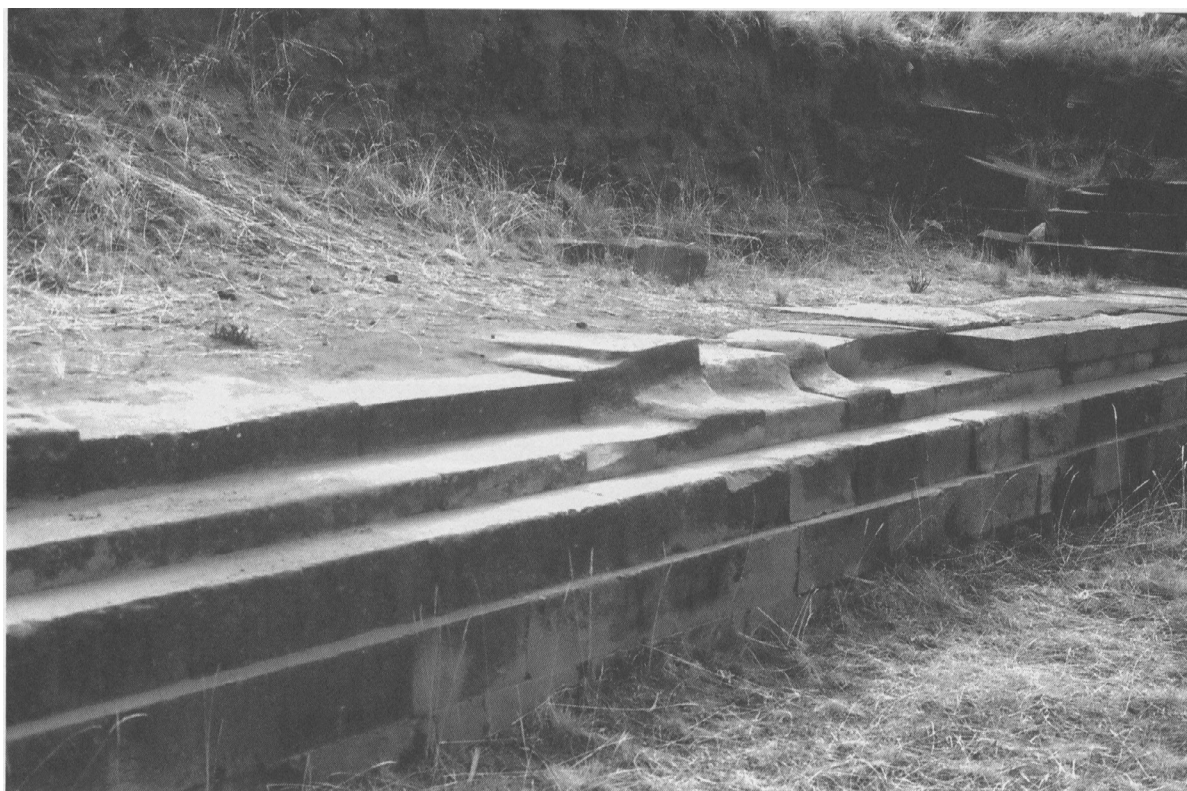
**Figure 2.48.** Stereobate on Pumapunku's south side with not fully carved top step (center) and infill with andesite blocks (right).

There is a question of how high the visible part of the stereobate really was. From the foundation stones, or bottom of the first course, to the top level it measures on average 1.06 m, but it is likely that the first course was in part hidden by the floor surrounding the entire structure. The profile about midway of Pumapunku's south side shows a suspect whitish thin stratum at about half the height of the first course.

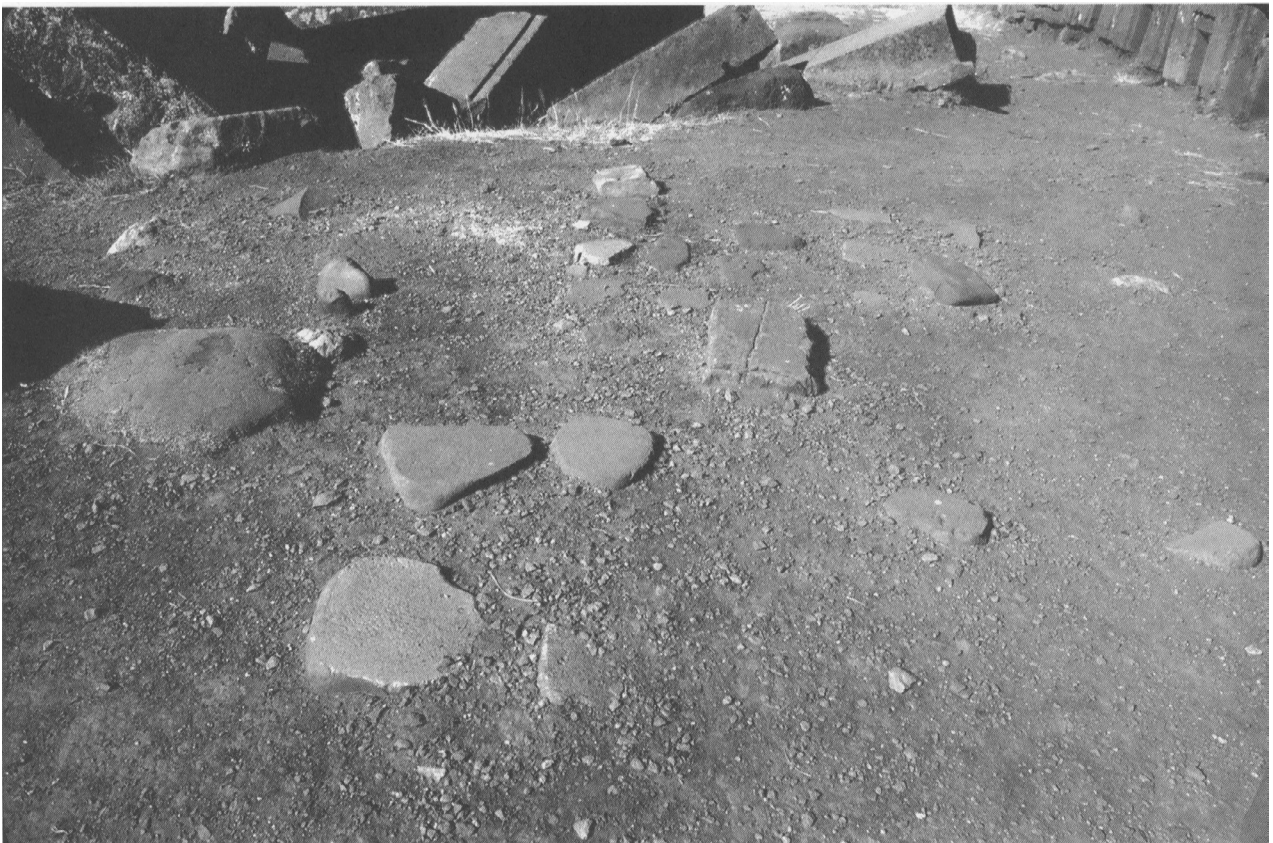
**Figure 2.56.** Foundation stones west of Platform IIa.

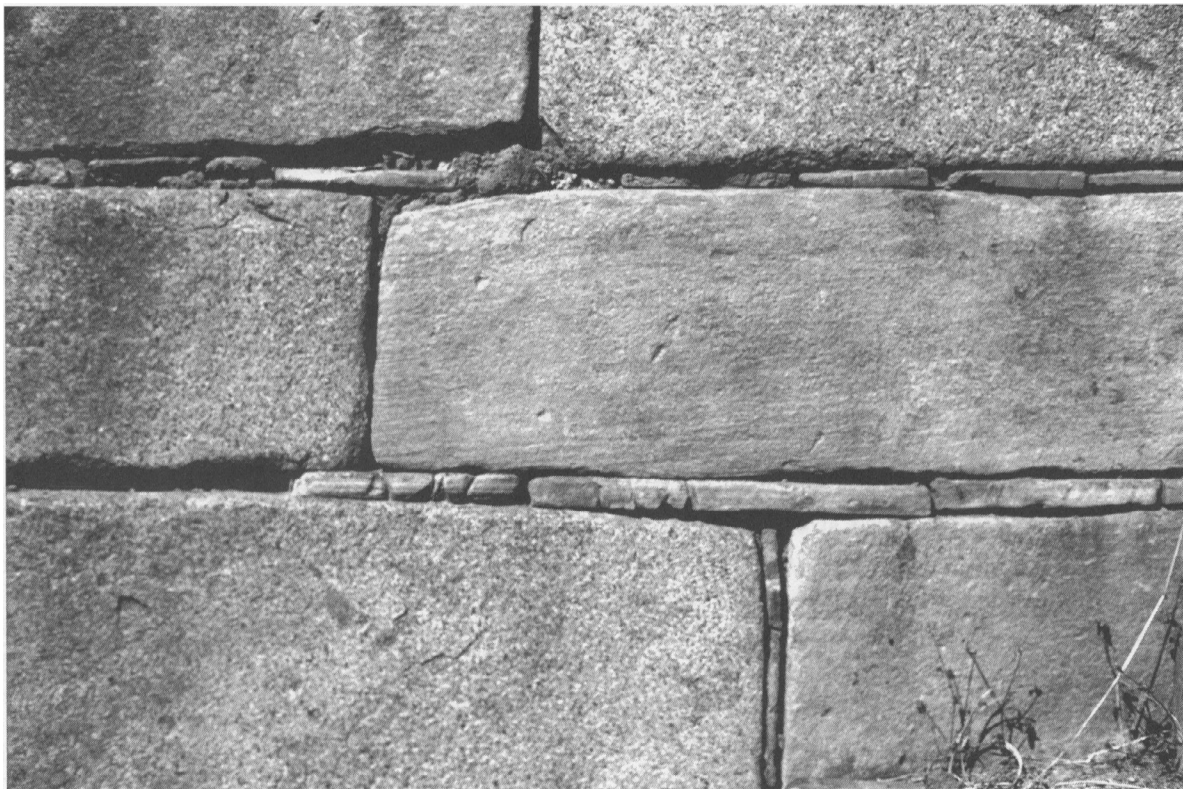
**Figure 2.70.** Chinked cut-stone masonry at Chavin de Huanter.

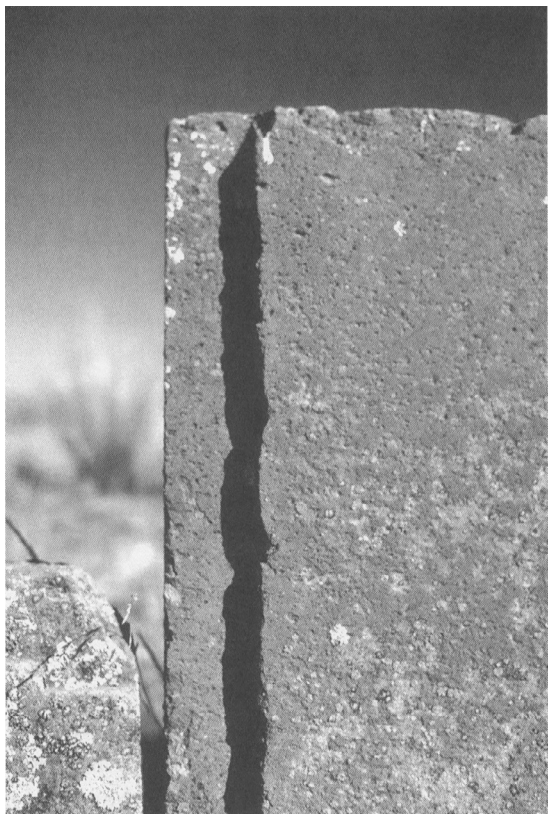
**Figure 3.1.** Straight rabbet.

Rabbits are longitudinal grooves cut along one or more edges of a stone (Figure 3.1). Some rabbits are straight, others are stepped at one or the other of their ends (Figure 3.2). Step moldings are L-shaped rectilinear moldings adding variety to plain surfaces (Figure 3.3). Dentils are small projecting rectangular blocks<sup>1</sup> (Figure 3.4).

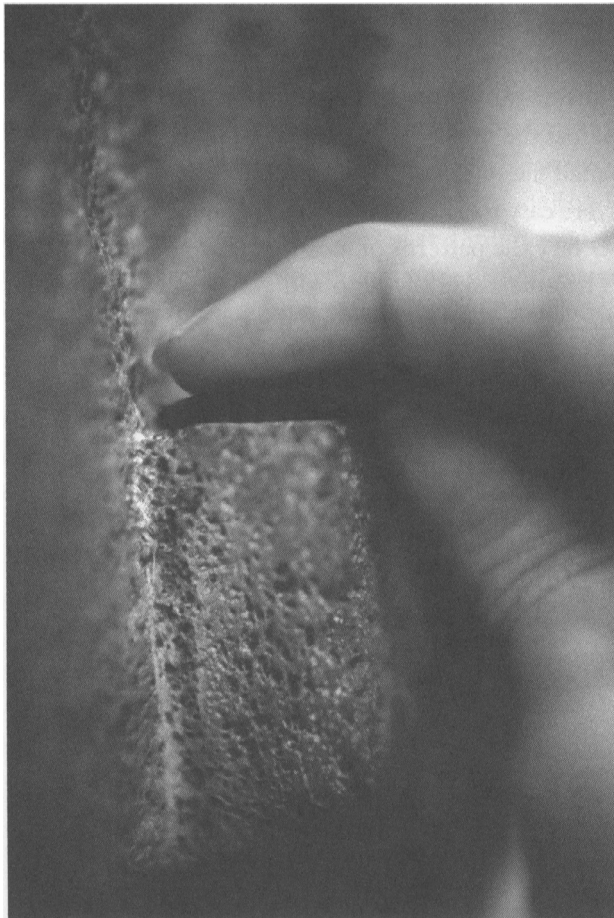
**Figure 5.13.** Obsidian being used as polisher and incisor.

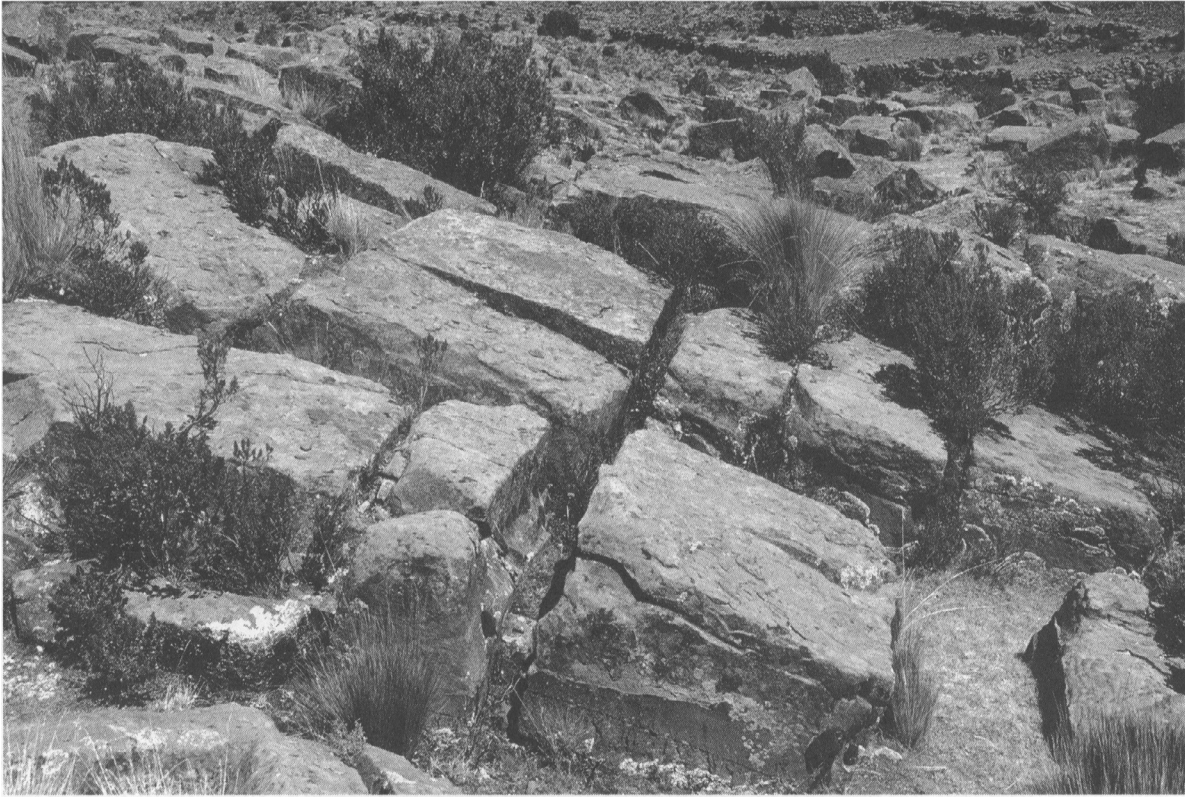
**Figure 6.4.** Natural fracture planes in the sandstone formation at Kaliri.

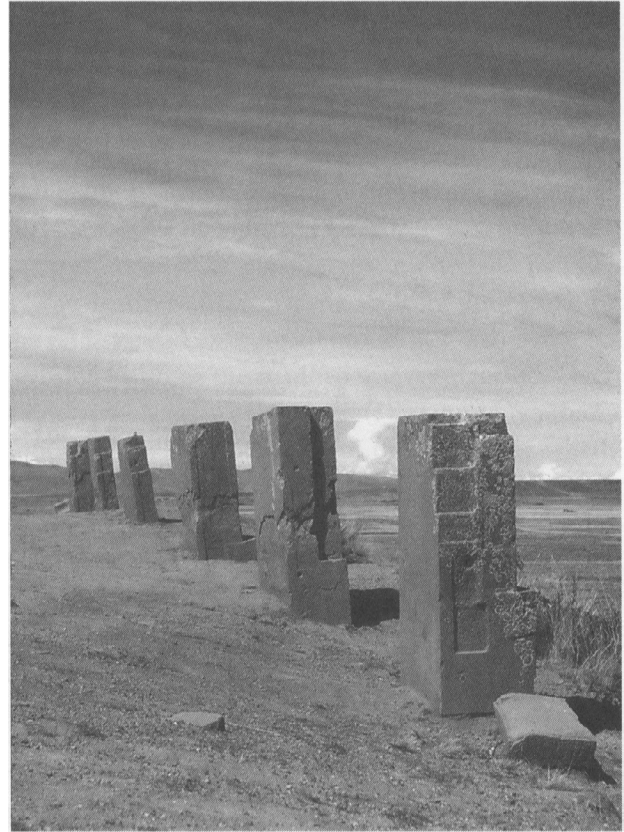
**Figure 6.9.** Imprints on the uprights on top of Akapana give clues to the position and size of the infill masonry.

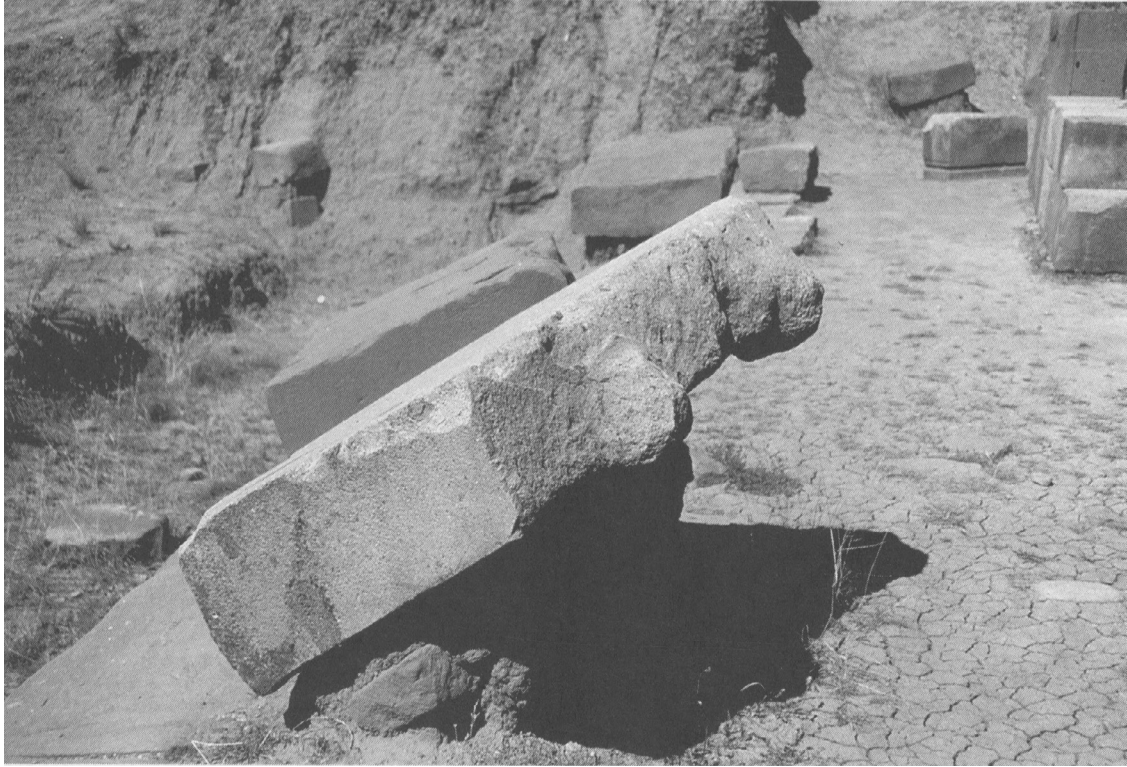
**Figure 6.13.** Protuberances or bosses to handle stones.

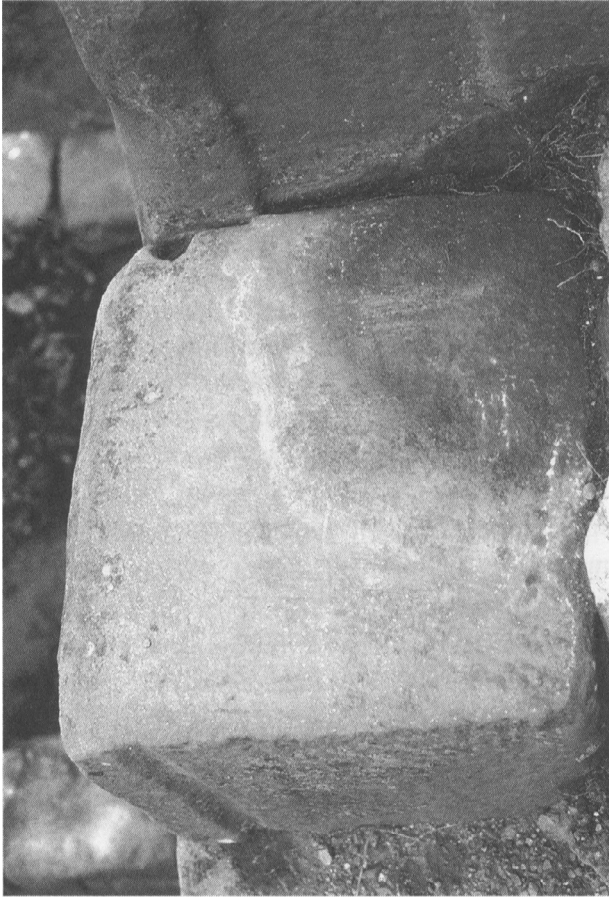
**Figure 6.22.** Rabbet joint on upright. Also note the rope chase on the block fitted to upright.

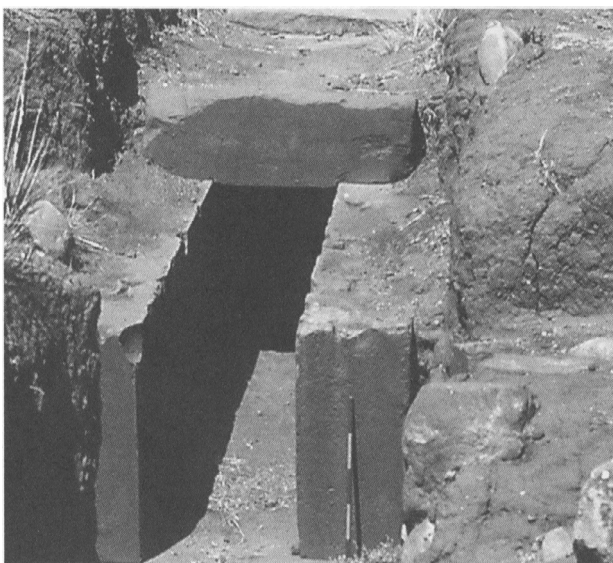
**Figure 6.24.** Canal with cover on Pumapunku, south side.

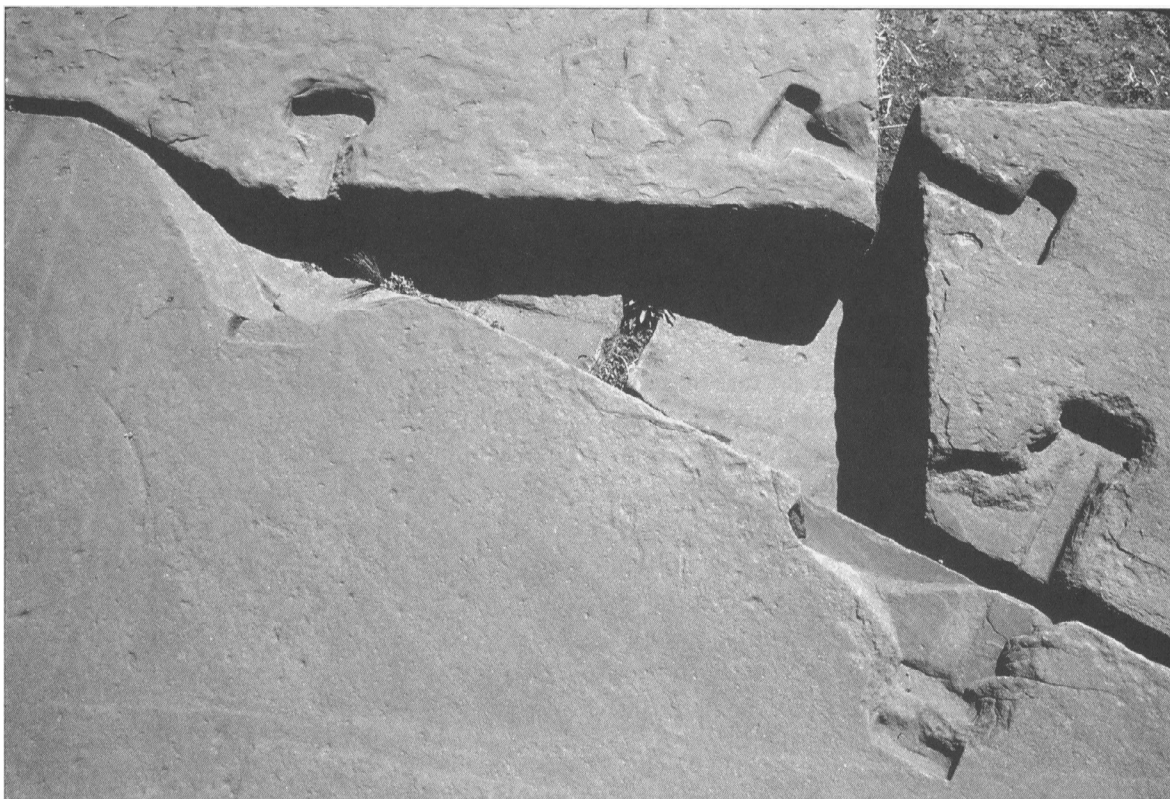
**Figure 6.25.** Cramp sockets on Platform III at Pumapunku.
